## TEST REPORT

REPORT NO.: HV-17-05788A-1

Product Name : Ceraz Ceramic Coating

Hardness by Pencil Test

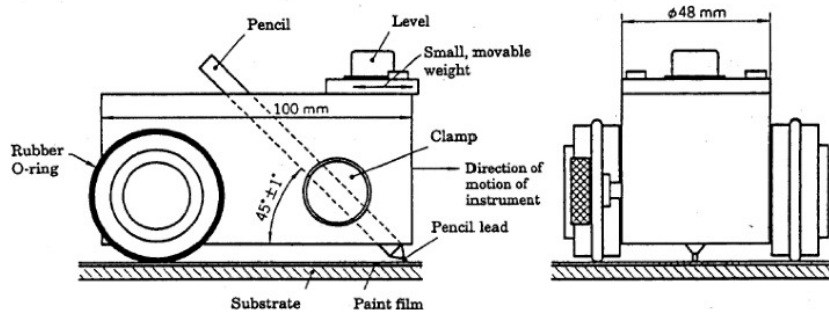
Test Equipment:

Name	Brand
Pencil	MITSU-BISHI uni

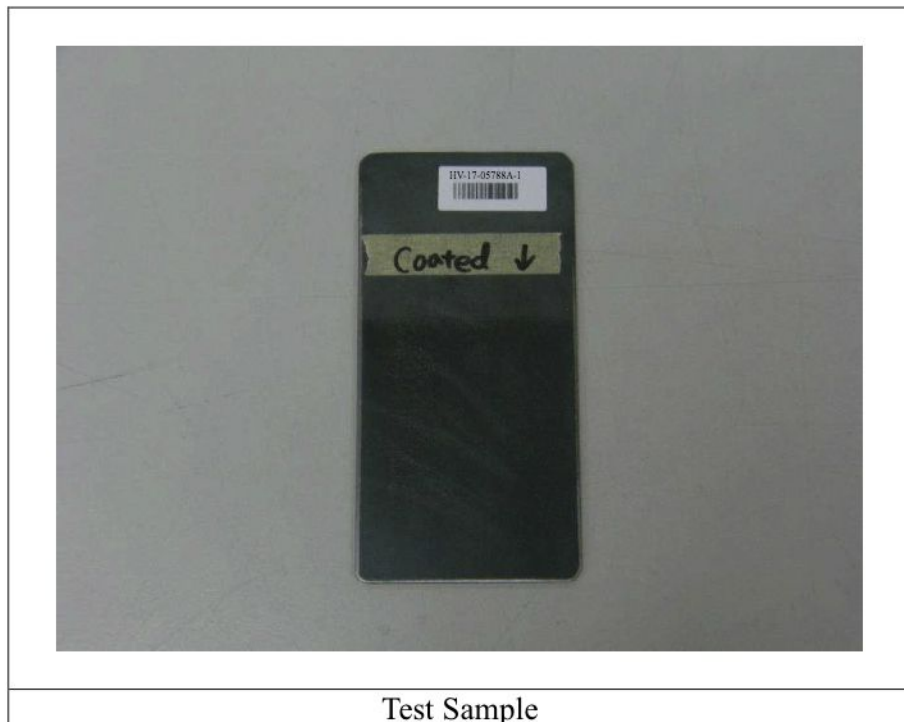
Test Photo:

Above 9H
